# Weathertightness testing an Argeton Rainscreen system of terracotta

Report No. N950/07/13946

N950/07/13946 16 OCTOBER, 2007

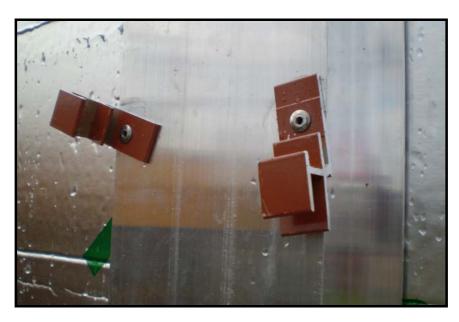
**PHOTO 20028**

During the dismantling of the sample no discrepancies from the drawings were found.

TILE SUPPORT CLIPS

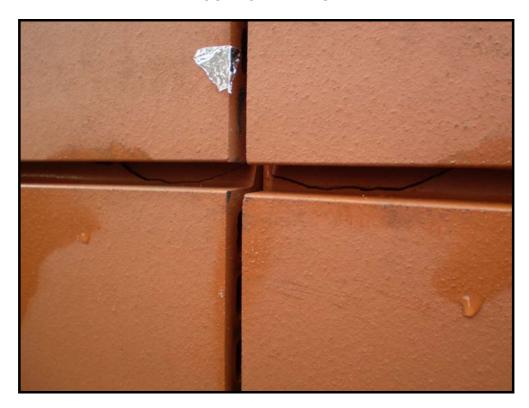
#### **PHOTO 20018**

500 Nm. The impact cracked the top of the tiles below. The tiles remained secure. See photo 20018.

#### **LOCATION 2 IMPACT**

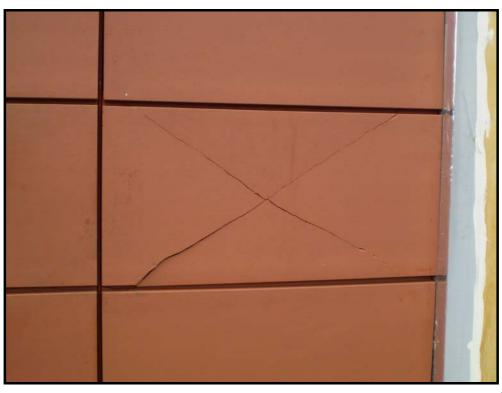
#### PHOTO 20025

10 Nm hard body. The tile cracked but remained secure. See photo 20025.

#### **LOCATION 7 IMPACT**
