# Weathertightness testing an Argeton Rainscreen system of terracotta

Report No. N950/07/13946

N950/07/13946 16 OCTOBER, 2007

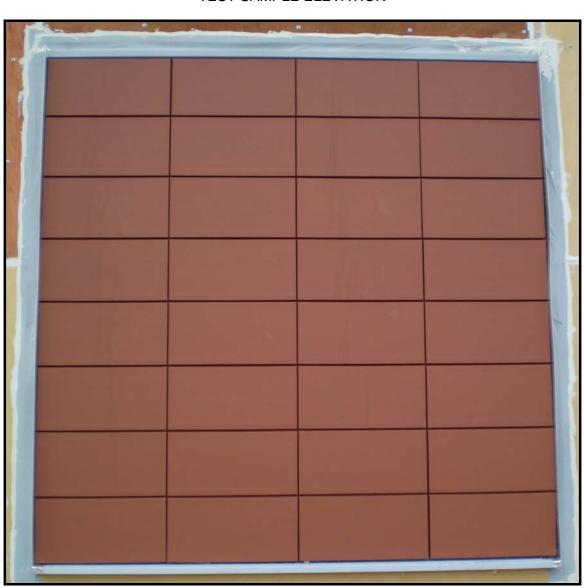
**PHOTO 00013**

The sample was as shown in the photo below and the drawings included as an appendix to this report.

The tiles measured 600 mm wide by 300 mm high and were supported by vertical rails at 600 mm centres.

The aluminium rainscreen carrier frame was secured to the backing wall framework with 2 coarse thread self drilling Tek screws at each fixing position.

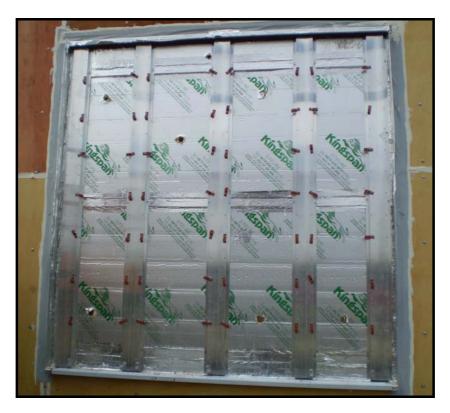
**PHOTO 20027**

During the dismantling of the sample no discrepancies from the drawings were found.

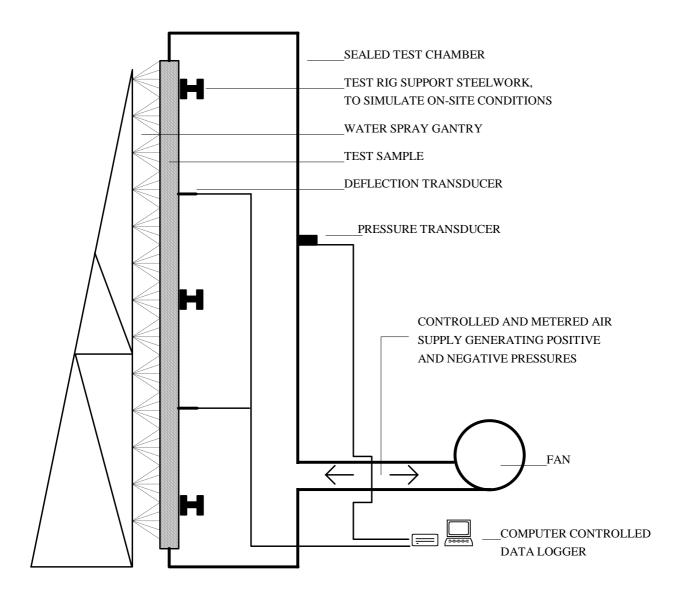
FIGURE 1

The test sample was mounted on a rigid test rig with support steelwork designed to simulate the on-site/project conditions. The test rig comprised a well sealed chamber, fabricated from steel and plywood. A door was provided to allow access to the chamber. Representatives of Telling installed the sample on the test rig. See Figure 1.
